DEPARTMENT OF TRANSPORTATION

Quality Assurance and Source Inspection

Contract #: 04-0120F4Cty: SF/ALA Rte: 80 PM: 13.2/13.9File #: 69.28**WELDING INSPECTION REPORT****Resident Engineer:** Siegenthaler, Peter**Address:** 333 Burma Road**City:** Oakland, CA 94607**Report No:** WIR-020458**Date Inspected:** 02-Feb-2011**Project Name:** SAS Superstructure**OSM Arrival Time:** 700**Prime Contractor:** American Bridge/Fluor Enterprises, a JV**OSM Departure Time:** 1900**Contractor:** Zhenhua Port Machinery Company, Ltd (ZPMC), Changxing Island **Location:** Shanghai, China**CWI Name:** Qiu Wen**CWI Present:** Yes No**Inspected CWI report:** Yes No N/A**Rod Oven in Use:** Yes No N/A**Electrode to specification:** Yes No N/A**Weld Procedures Followed:** Yes No N/A**Qualified Welders:** Yes No N/A**Verified Joint Fit-up:** Yes No N/A**Approved Drawings:** Yes No N/A**Approved WPS:** Yes No N/A**Delayed / Cancelled:** Yes No N/A**Bridge No:** 34-0006**Component:** Orthotropic Box Girder(OBG)**Summary of Items Observed:**

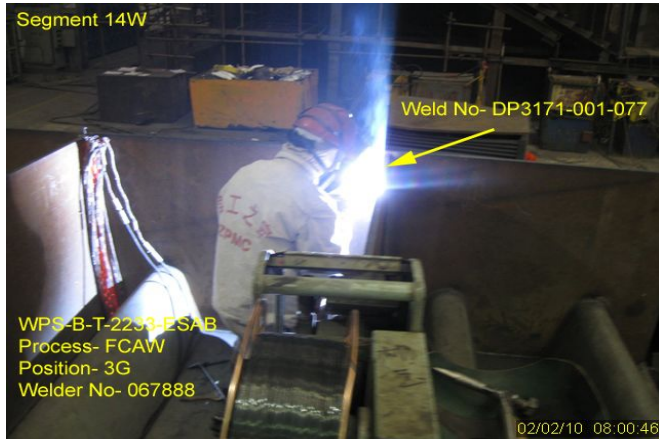
This QA Inspector observed ZPMC qualified welding personnel identified as 067888 perform Flux Cored Arc Welding (FCAW), weld joint identified as DP3171-001-077; located On Orthotropic Box Girder (OBG) Deck Plate to Deck Panel diaphragm CJP Weld; ABF Quality Assurance (QA) is identified as Mr. Shen Jian Yuan. This QA Inspector observed a welding current of approximately 240 amps and 26 volts and the base material appears to have been being preheated by an electrical heating elements prior to welding. ABF Quality Assurance (QA) Mr. Shao Jian Yuan was onsite monitoring the welding variables. The welding variables recorded by QA appeared to comply with applicable WPS-B-T-2233-ESAB. See attached photo for further details.

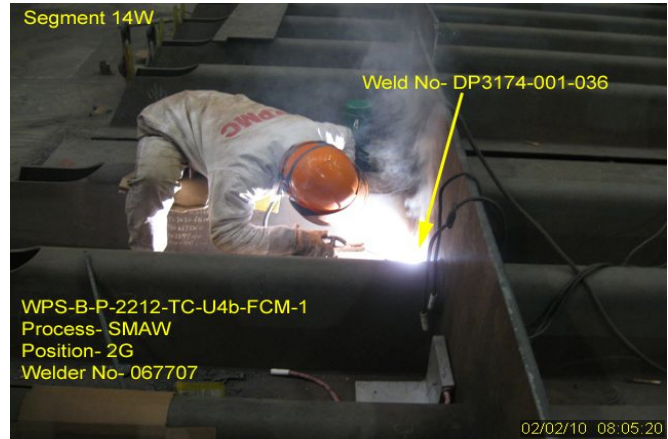
This QA Inspector observed ZPMC qualified welding personnel identified as 067707 perform Shielded Metal Arc Welding (SMAW), weld joint identified as DP3174-001-035; located On Orthotropic Box Girder (OBG) Deck Panel to Stiffener CJP Weld; ABF Quality Assurance (QA) Mr. Shao Jian Yuan was onsite monitoring the welding variables. The welding variables recorded by QA appeared to comply with applicable WPS-B-P-2212-TC-U4b-FCM.1. See attached photo for further details.
